## Investigation of Impact Damage of PMC Specimens using SEM

### ABSTRACT

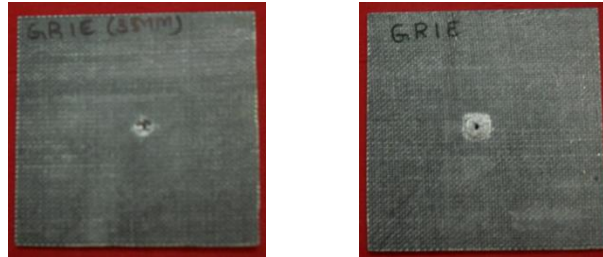
**Fig 3.1: Impacted surface & back surface of Graphite /Epoxy Test Specimens after Impact**

The impact damaged specimens (fig 3.1 & 3.2) were inspected with scanned image microscopy (i.e., Scanning Electron Microscopy, SEM). The damage was confined locally to the areas centred at the impact location, which suggests that the interior damage was characterized by delamination and cracks. The delamination damage was due to the bending-induced stresses.

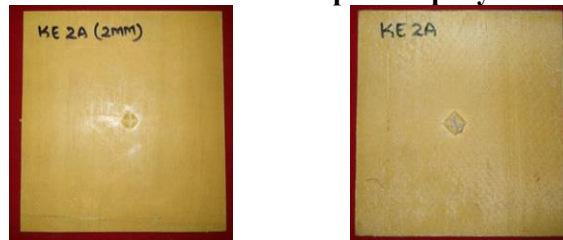
**Fig 3.2: Impacted surface & back surface of Kevlar /Epoxy Test Specimens after Impact**

In general, internal delaminations are peanut shaped and elongated in the fiber directions as indicated in Fig 3.2 and Fig 3.3 for Graphite/Epoxy as well as Kevlar/Epoxy respectively.
